REPORT TO: Truss Hook LLC

PROJECT: Load Testing of
Lifting Device

PSI PROJECT NO.: 0823305-1

DATE: January 23, 2012

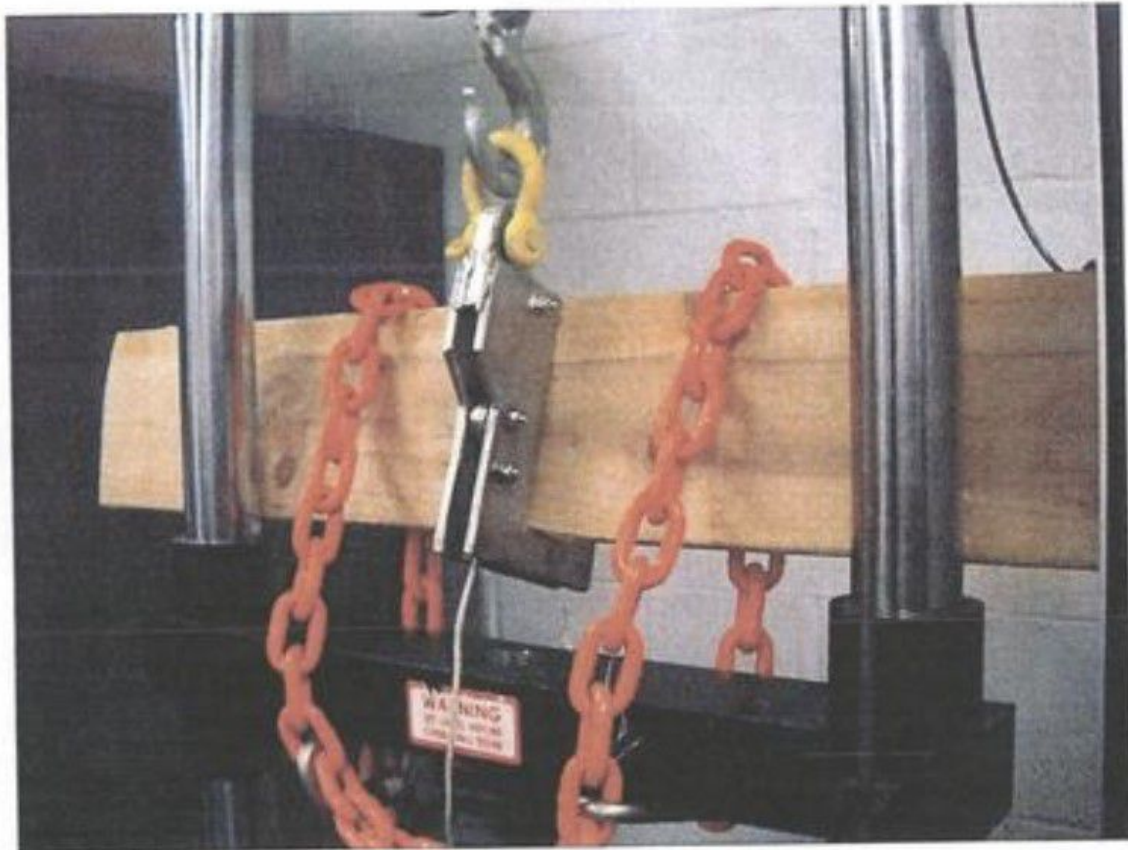
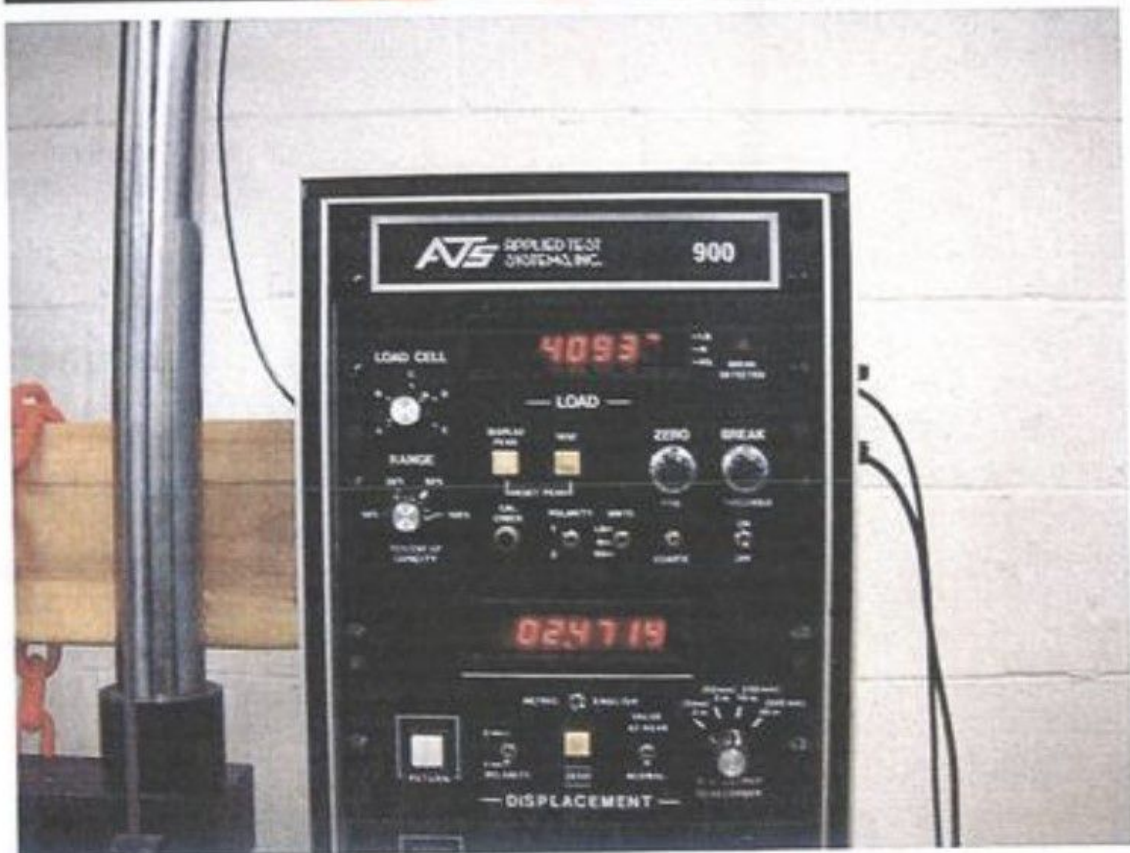
PHOTOS

Photos of the test set-up are attached.

Testing was performed in accordance with the scope contained in our proposal. Testing was accomplished by attaching the eye of the lifting device to the upper head of the ATS testing machine, and inserting a piece of 2"x6" nominal dimension lumber that was fastened to the lower platen of the machine into the device. The lifting device was then loaded in tension to a minimum of 4,000 lbf. The test load was provided by our client.

The lifting device held the 4,000 lbf load for a minimum of one (1) minute duration.

After release of the load, the device was visually inspected for any damage. None was noted.
